Manhole Inspection Summary

Manhole # S45U__020MH

Location Address: **1520 Cuba Street**

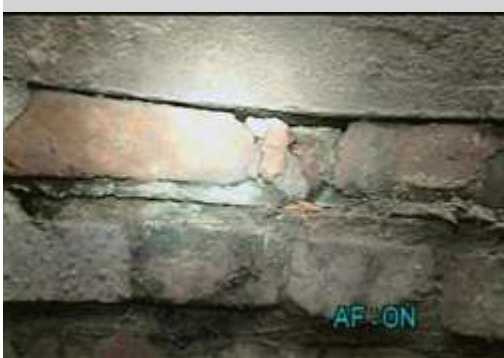
Defect 2

Condition: ☐ Sound ☐ Cracked ☐ Root Intrusion ☐ Loose Brick ☒ **Deteriorated**

frame adjustment deterioration

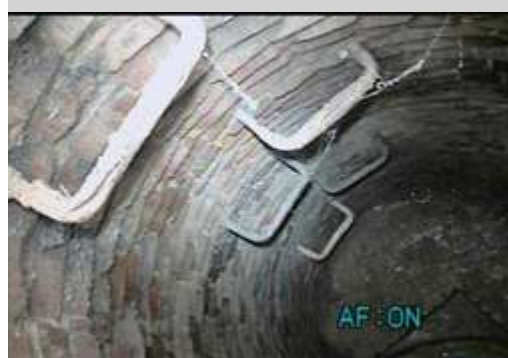
Defect 1

Steps Count: **5** Missing: **0** ☒ **Corroded**

corroded steps

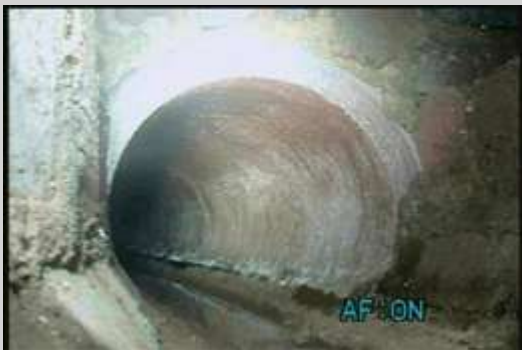
12 O'Clock Outflow

8 in. Circular Gravity Sewer
Pipe Out @ 12 O'Clock

Invert Depth: **9.92** (ft.) Flow Characteristics: **Slow**

Deposits: ☒ None ☐ Mud ☐ Sludge ☐ Debris ☐ Grease

Infiltration: **None** Pipe Seal Cond: **Unknown**

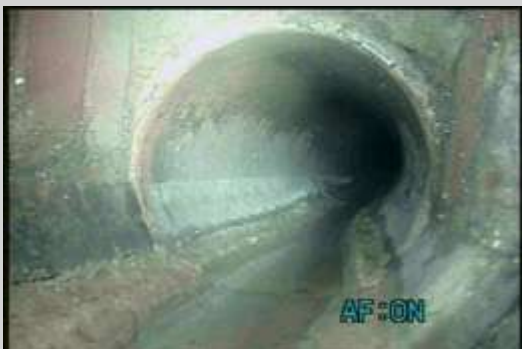
9 O'Clock Inflow

8 in. Circular Gravity Sewer
Pipe In @ 9 O'Clock

Invert Depth: **9.83** (ft.) Flow Characteristics: **Slow**

Deposits: ☒ None ☐ Mud ☐ Sludge ☐ Debris ☐ Grease

Infiltration: **None** Pipe Seal Cond: **Unknown**
